HP CP3520, HP CP 3525 and HP CM 3530™

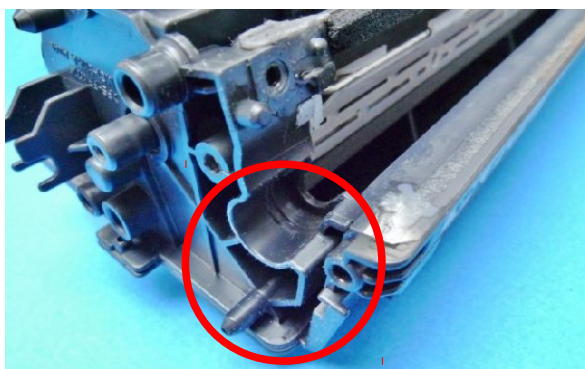
1. Picture

This picture shows the old style OEM hopper.

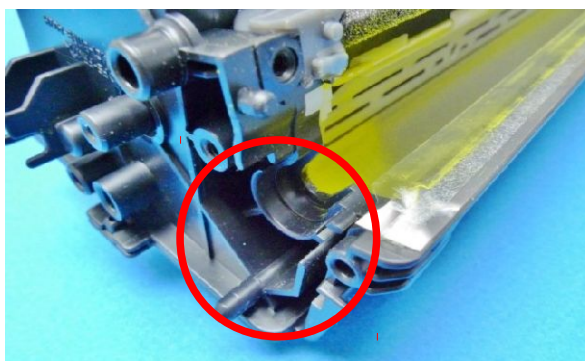
2. Picture

This picture shows the new style OEM hopper.

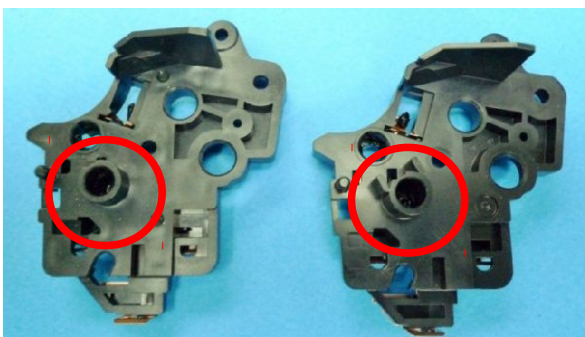
3. Picture

Investigation by Delacamp has shown that there are two different versions of the CE25x cartridges. There are small differences in the toner hopper and one end cap which mean that the two types are not interchangeable. (see photo 1, 2 and 3) Mixing of these components leads to problems in assembly. If not noticed the misalignment will lead to very high load on the printer drive motor, causing the printer to stop.

This picture shows the different versions of contact side inner end cap. (left old style, right new style)
