HP P3015, HP P2055, HP CP3525, HP CP4525 etc.

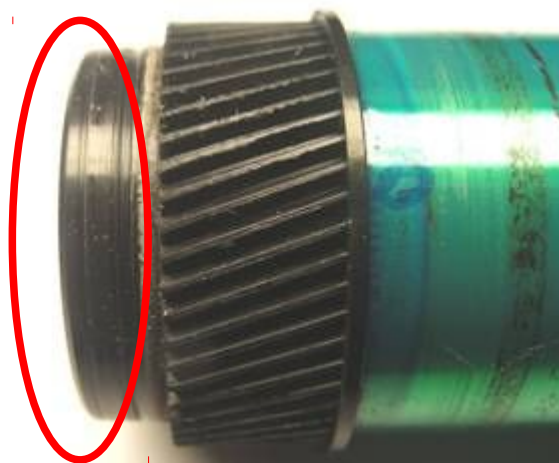
1. Picture

Investigation by Delacamp has shown that heavy wear of OPC drive gears and bearings in the above machines can be caused by toner contamination of the OEM grease and occurs when the grease is not replaced. Toner contaminates the grease during disassembly, cleaning and re-assembly of the cartridge. This toner then causes the wear on the gear and bearing. Delacamp strongly recommends that the OEM grease is removed during the cleaning process and is replaced with new grease during assembly

The picture shows the wear on an HP P3015 OPC gear after printing 12.000 pages. This gear was used with contaminated OEM grease
