## SAMSUNG ML 1910/1915 - MLT-D1052

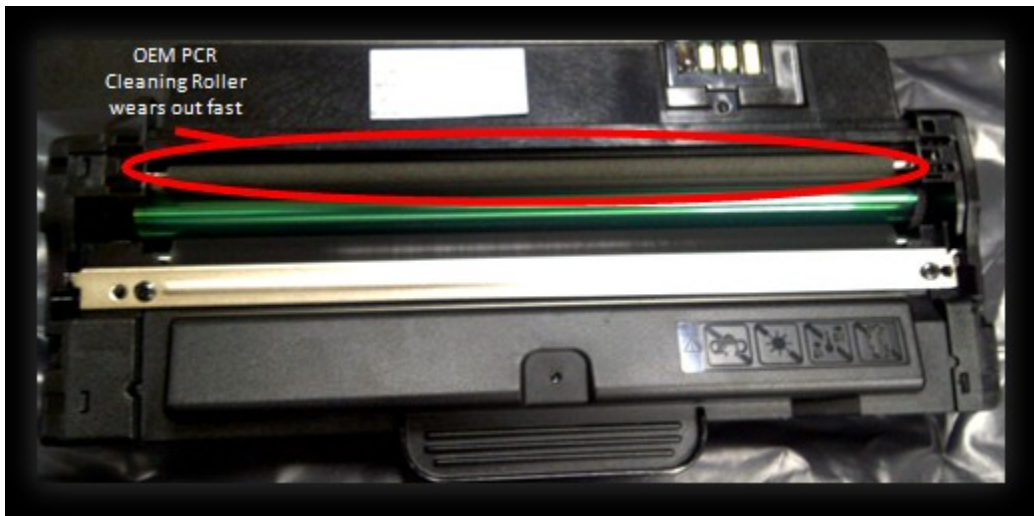
Investigation by Delacamp has shown that the ML-1910 series OEM cartridges have a PCR cleaning roller (see below) that wears out fast. This problem leads to insufficient PCR cleaning and in the end to bad printouts.

The Delacamp Wiper Blade ([Item number 30073](#)) with the PCR cleaning felt is an effective yet inexpensive solution.
